# Certificate of testing

## Crash Test according to ISO 7176-19 - 2008

### Wheeled mobility devices for use in motor vehicles

<b>Assignment:</b>	Crash testing of wheel chair and WTORS according to ISO 7176-19 annex A and B
<b>Date of testing:</b>	27 February 2018
<b>Test object:</b>	Medema mini crosser X model
<b>Mass of wheelchair:</b>	160kg
<b>Serial no:</b>	not informed
<b>WTORS:</b>	Dahl WTORS, meeting the requirements set out in clause 4.1 Wheelchair restraint – 4 p. Heavy duty tie down straps Occupant restraint – Dahl 3point seat belt #500984
<b>Test dummy:</b>	Hybrid II 50% dummy with mass of 77 Kg.
<b>Measuring:</b>	Accelerometers mounted on the crash test sled measured the deceleration.
<b>Photografi:</b>	The test was filmed with a high speed camera at 500 fps. Still pictures, pre and post-test.

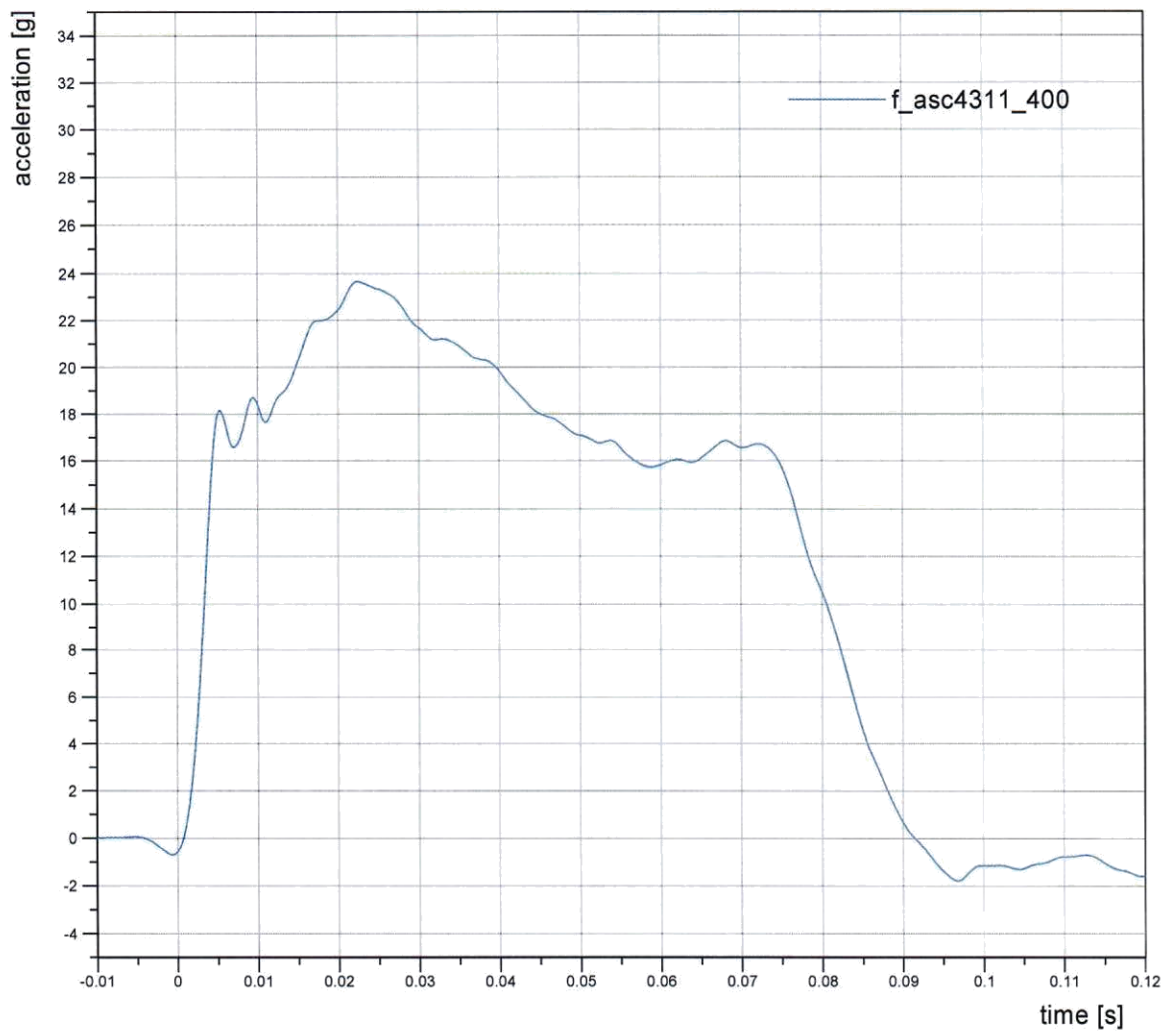
**SLED ACCELERATION**

<b>Sled deceleration and speed:</b>	See page with plotted graph and speed
-------------------------------------	---------------------------------------

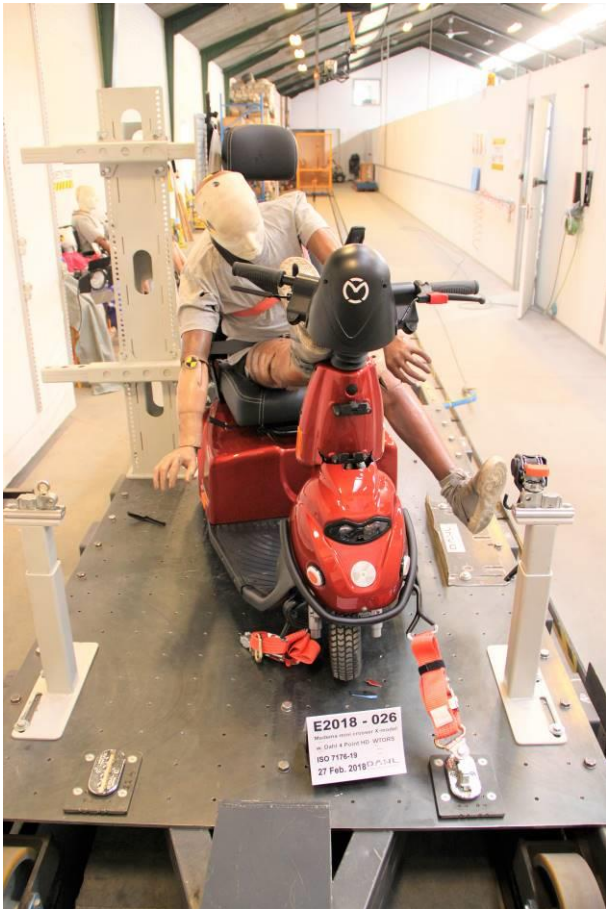
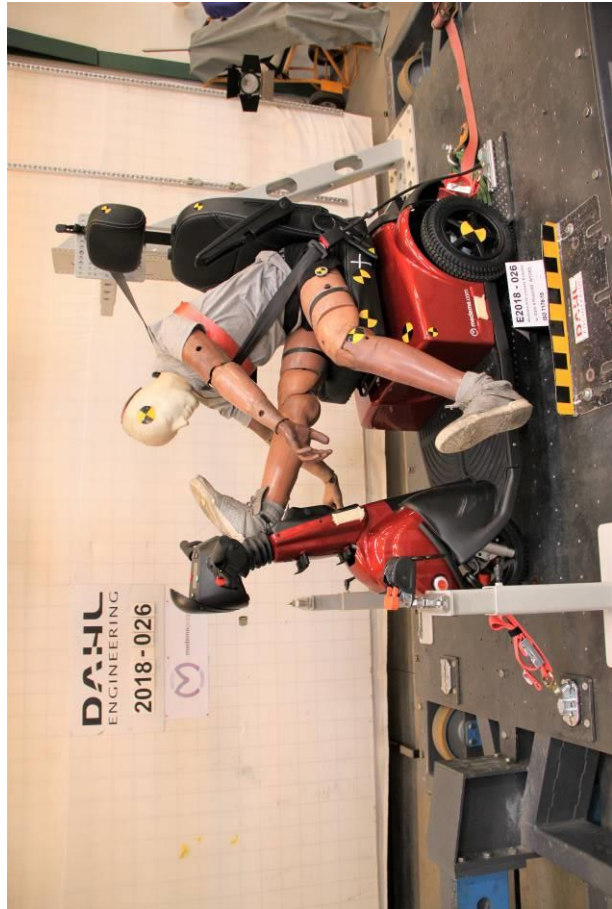
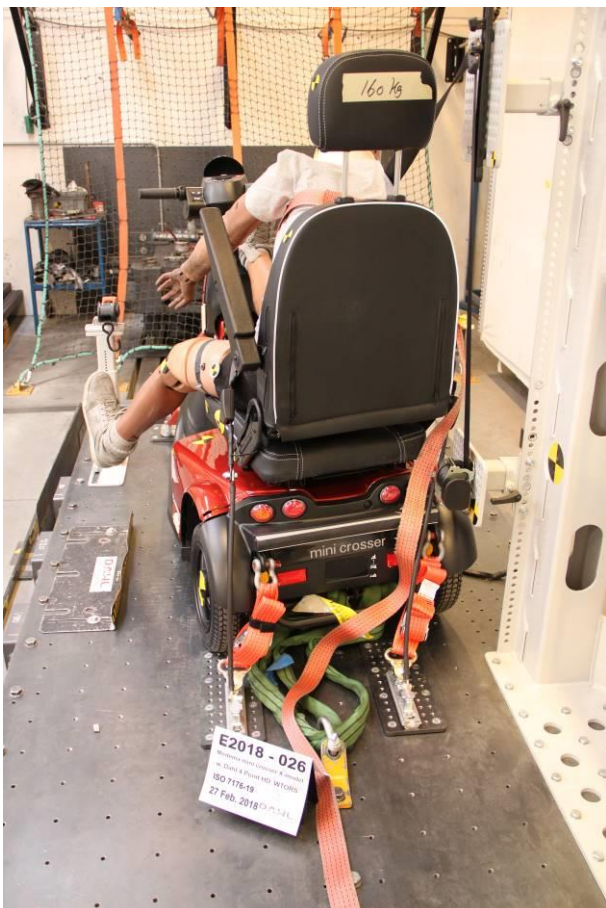
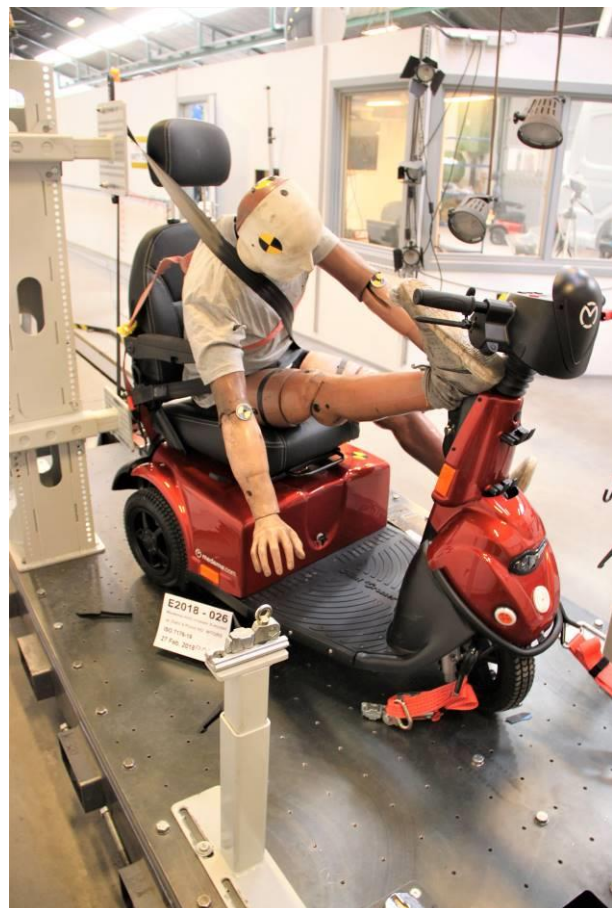
Post test photos

(b)	The were no visible signs of material failure on the wheelchair securing points	X
(c)	There were no components, fragments or accessories of the wheelchair with a mass of more than 100g that completely separated from the wheelchair	X

(d)	There were no fragmented or separated component, that may contact the occupant, produced with sharp edges less than radius 2 mm	X
(e)	There were no visible signs of failure on the wheelchairs primary load carrying components	X

(f)	There were no visible signs of failure on the wheelchairs seat adjusters	X
(g)	The ADT was removed from the wheelchair without the use of tools	X
(h)	The wheelchair was released from the tie-down system without the use of tools	X

(i)	The post test decrease of the mean H-point height is not more than 20%	X
(j)	Wheelchair and components did not cause partial or complete failure of the webbing of any of the WTORS assemblies during the test	X
